THE COUNTY SECONDARY SCHOOL

WOTTON-UNDER-EDGE, GLOUCESTERSHIRE.

CONSTRUCTION OF A SWIMMING POOL.

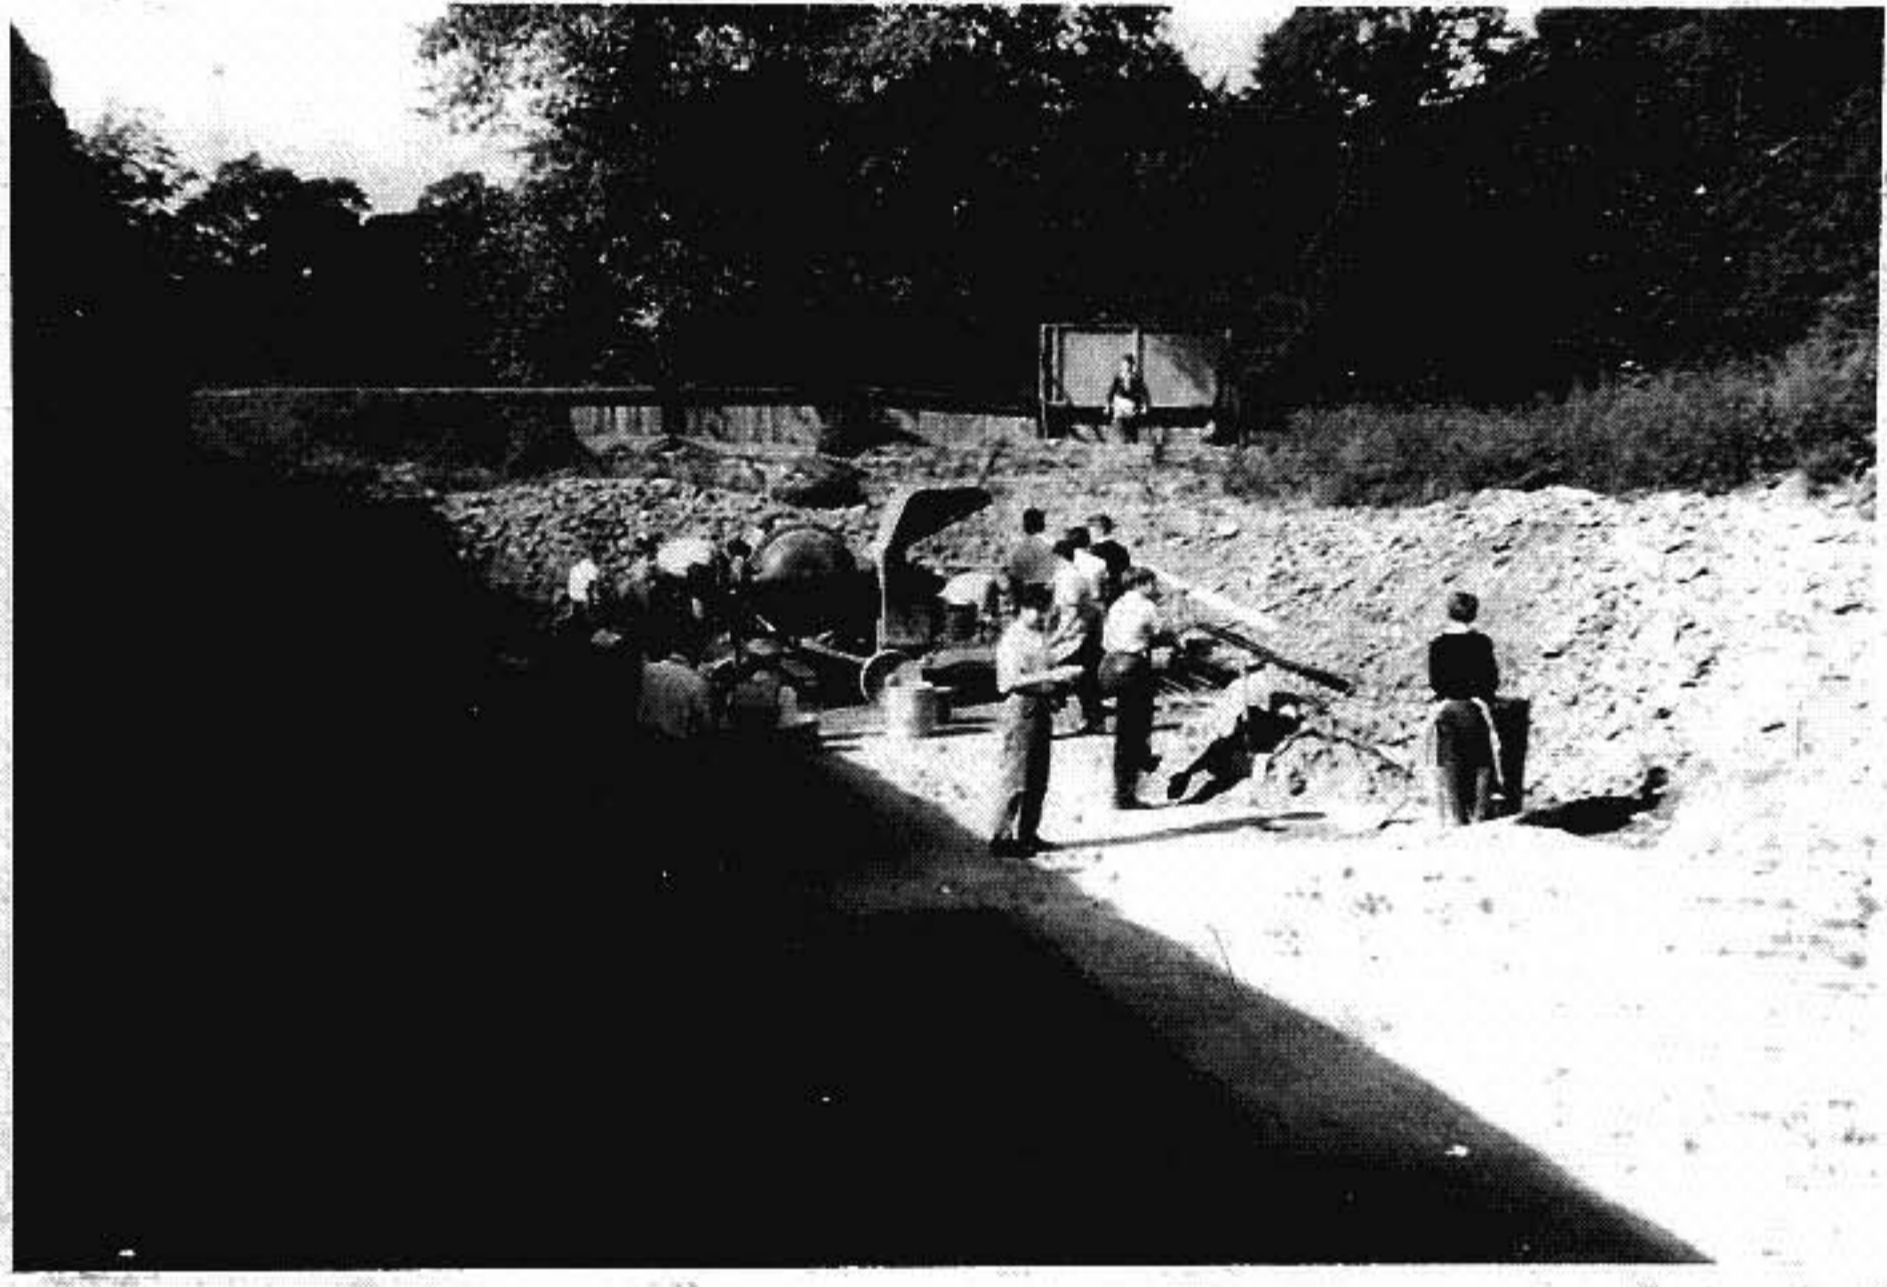
THE BLINDING LAYER LAID

Whilst working with the concrete for the blinding, it was found that as the layer was rather shallow, we were finding it difficult to obtain a smooth surface as a finish. Consequently, the amount of limestone chippings **was** slightly reduced and the amount of concreting sand increased to correspond, whilst a slightly larger amount of cement was put in to each mix going through the mixer. This enabled us to produce a cast giving the **desired surface** although costing a little more than had **been hoped**.

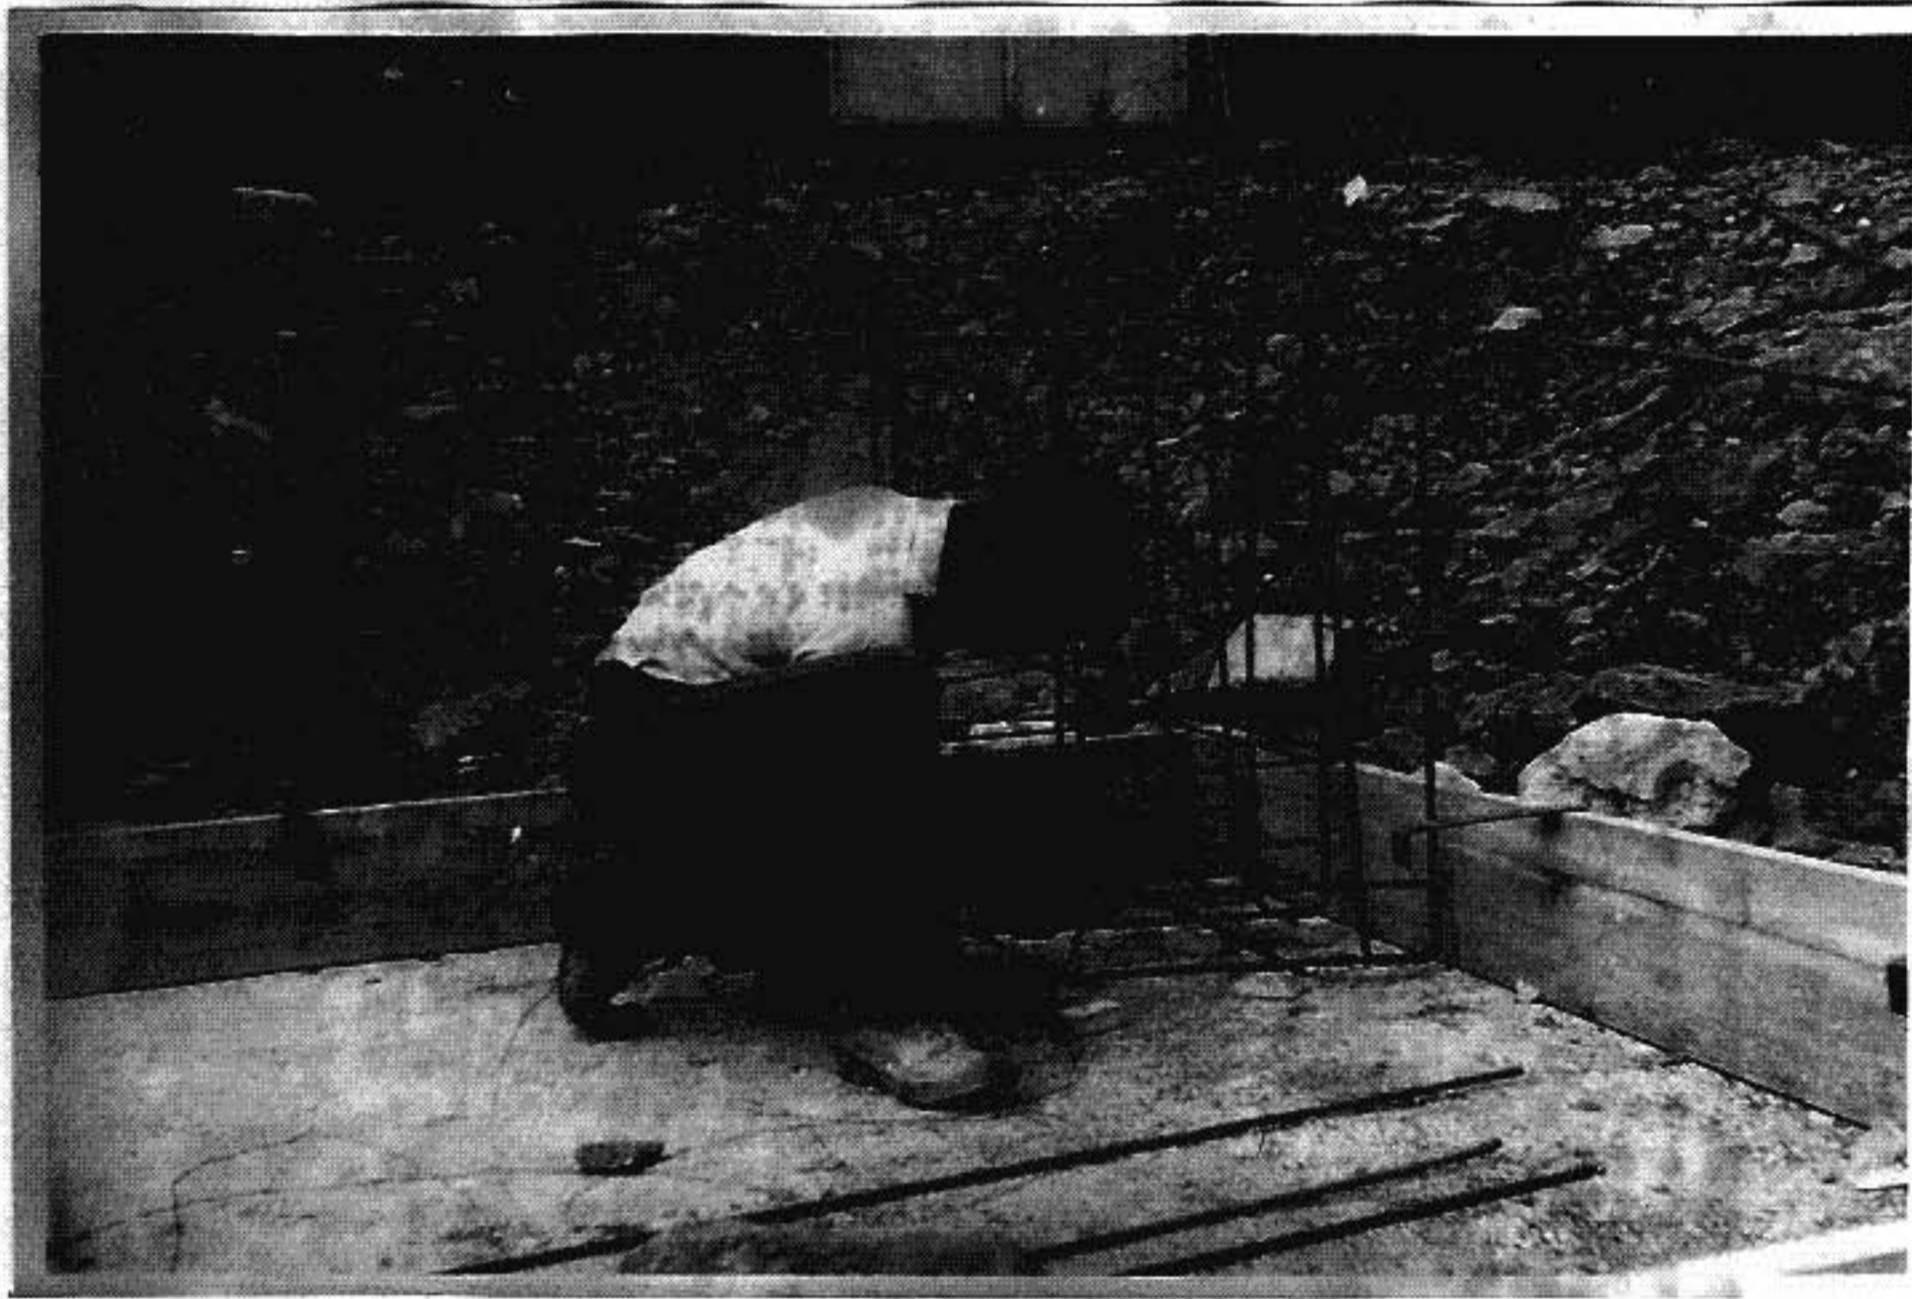
REINFORCING COMMENCED.

across the shallow end of the pool, and supported by small squares of concrete, 1" off the blinding layer. These bars were set 12" apart and a further three 20' lengths of steel were set 4" above them. The upright bars in the wall at the shallow end were next wired to the bars set in the base and these uprights were then interconnected by steel bars stretching right across the length of the wall, set at 10" intervals to each other. In this way, the double reinforcing skin of the wall was formed.

To set the steel in position the boys worked in pairs under the overall guidance of the "two foremen" and myself. The reinforcing plans were shown to all concerned and were practically self explanatory. The steel was interconnected by binding, using pliers and soft binding wire. It was found to be important that no small ends of this binding wire stuck out to protrude through the base or the walls and so give an opening for water seepage to commence. If seepage did take place in this fashion, it was explained that the water would tend to follow the run of the steel until a further outlet was found on the outer face of the walls.

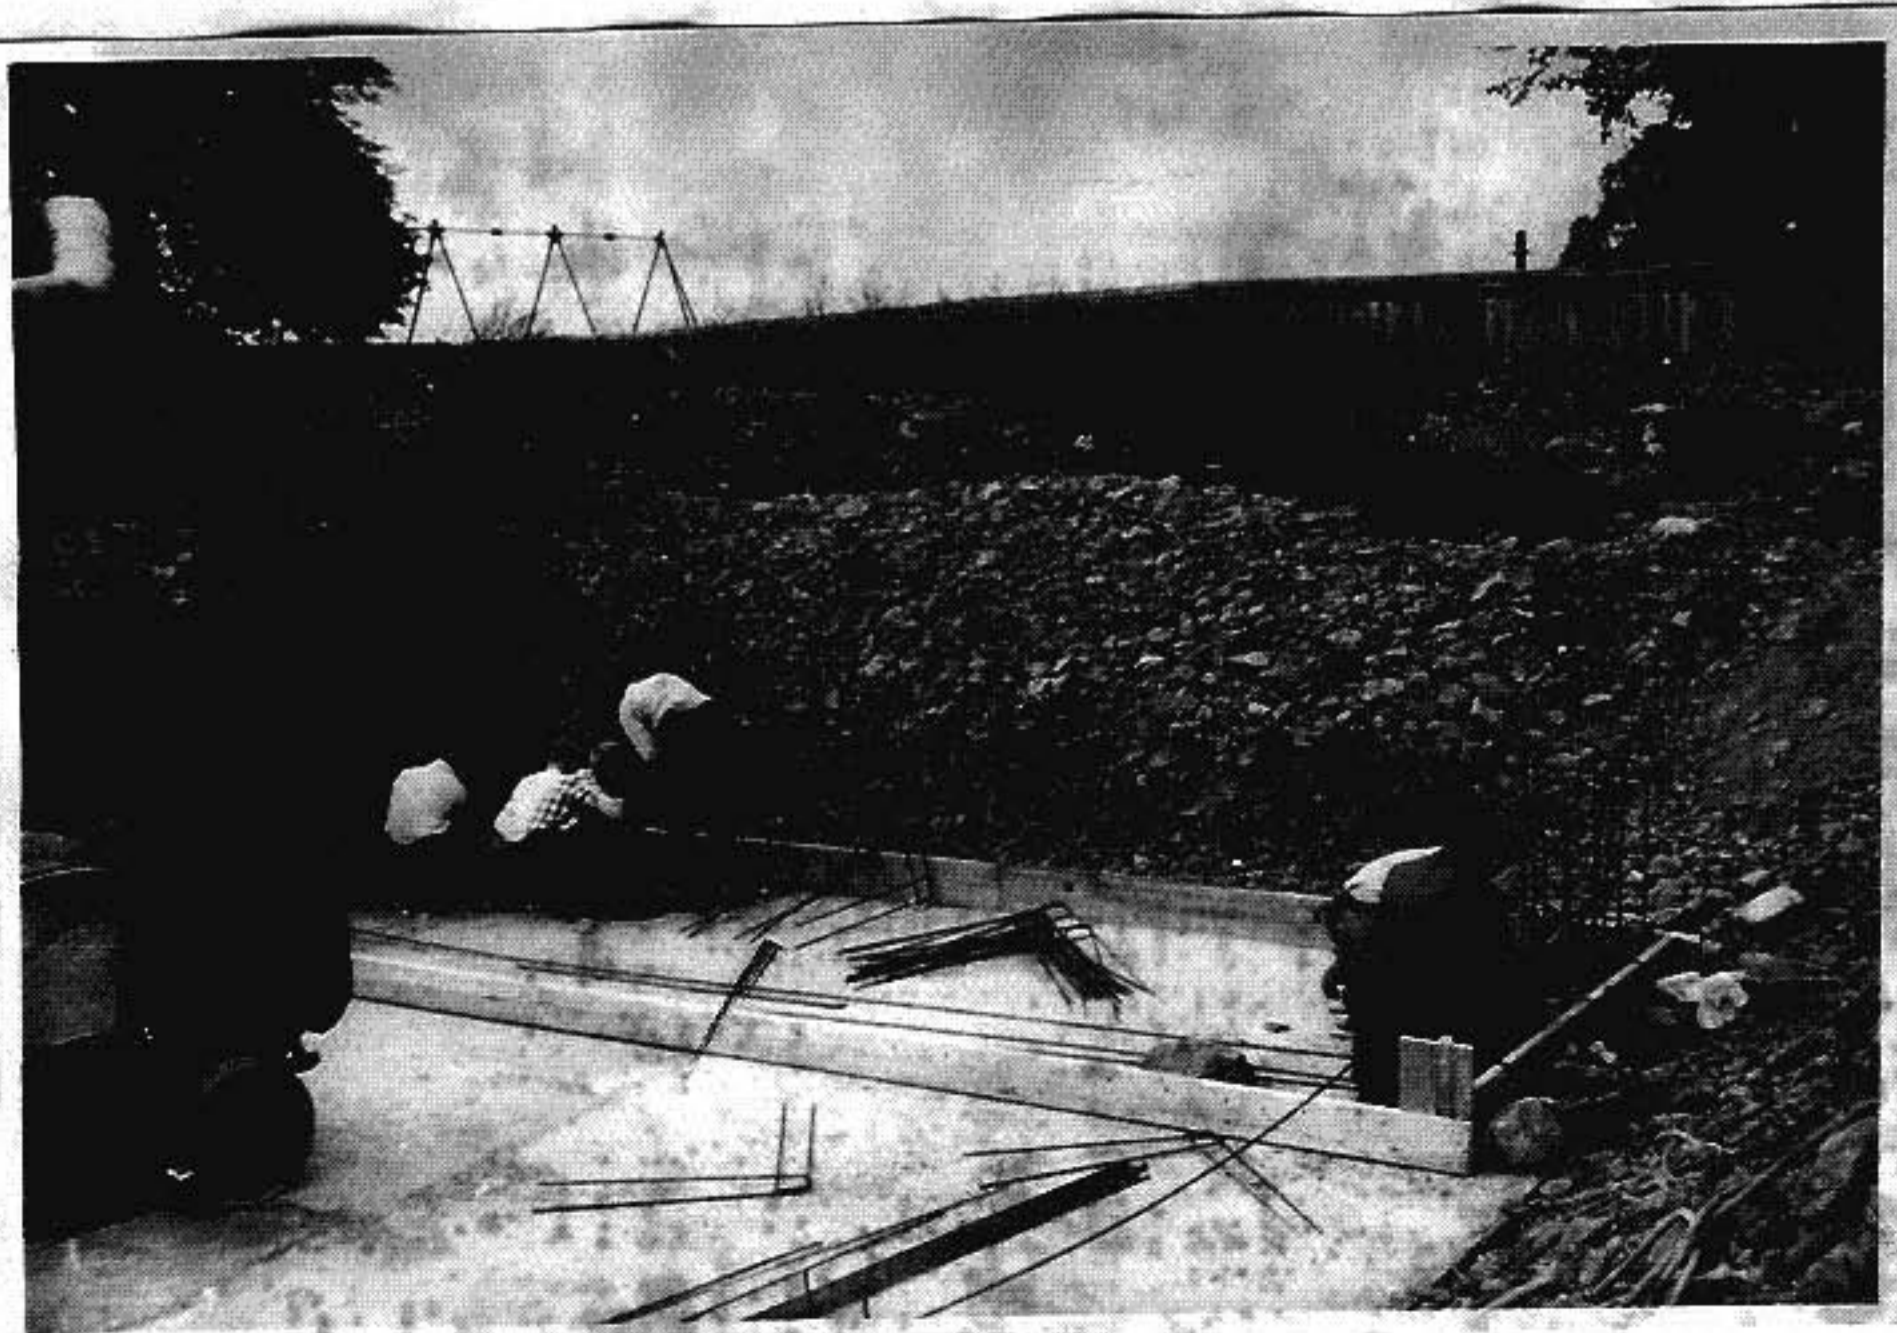
PREPARING THE FIRST CAST.

Six 20' lengths of steel were then fed through each end of the movable shutter and placed in position in the outer edge of the base, as had been done across the shallow end. They were fixed to the steel already laid in the base and fixed 1" and 5" above the blinding layer as the previous bars had been. The steelwork in the side walls was then wired to them for the first 7 feet of the walling, and these uprights were again interconnected by their own stretcher bars to form the double reinforcing skin of the side walls. To complete the necessary reinforcing at this stage, special angle pieces were wired into the two corners of the walls now formed, so that all steelwork in the part of the base to be cast, plus all the steelwork in the walls above this part of the base had now been set.

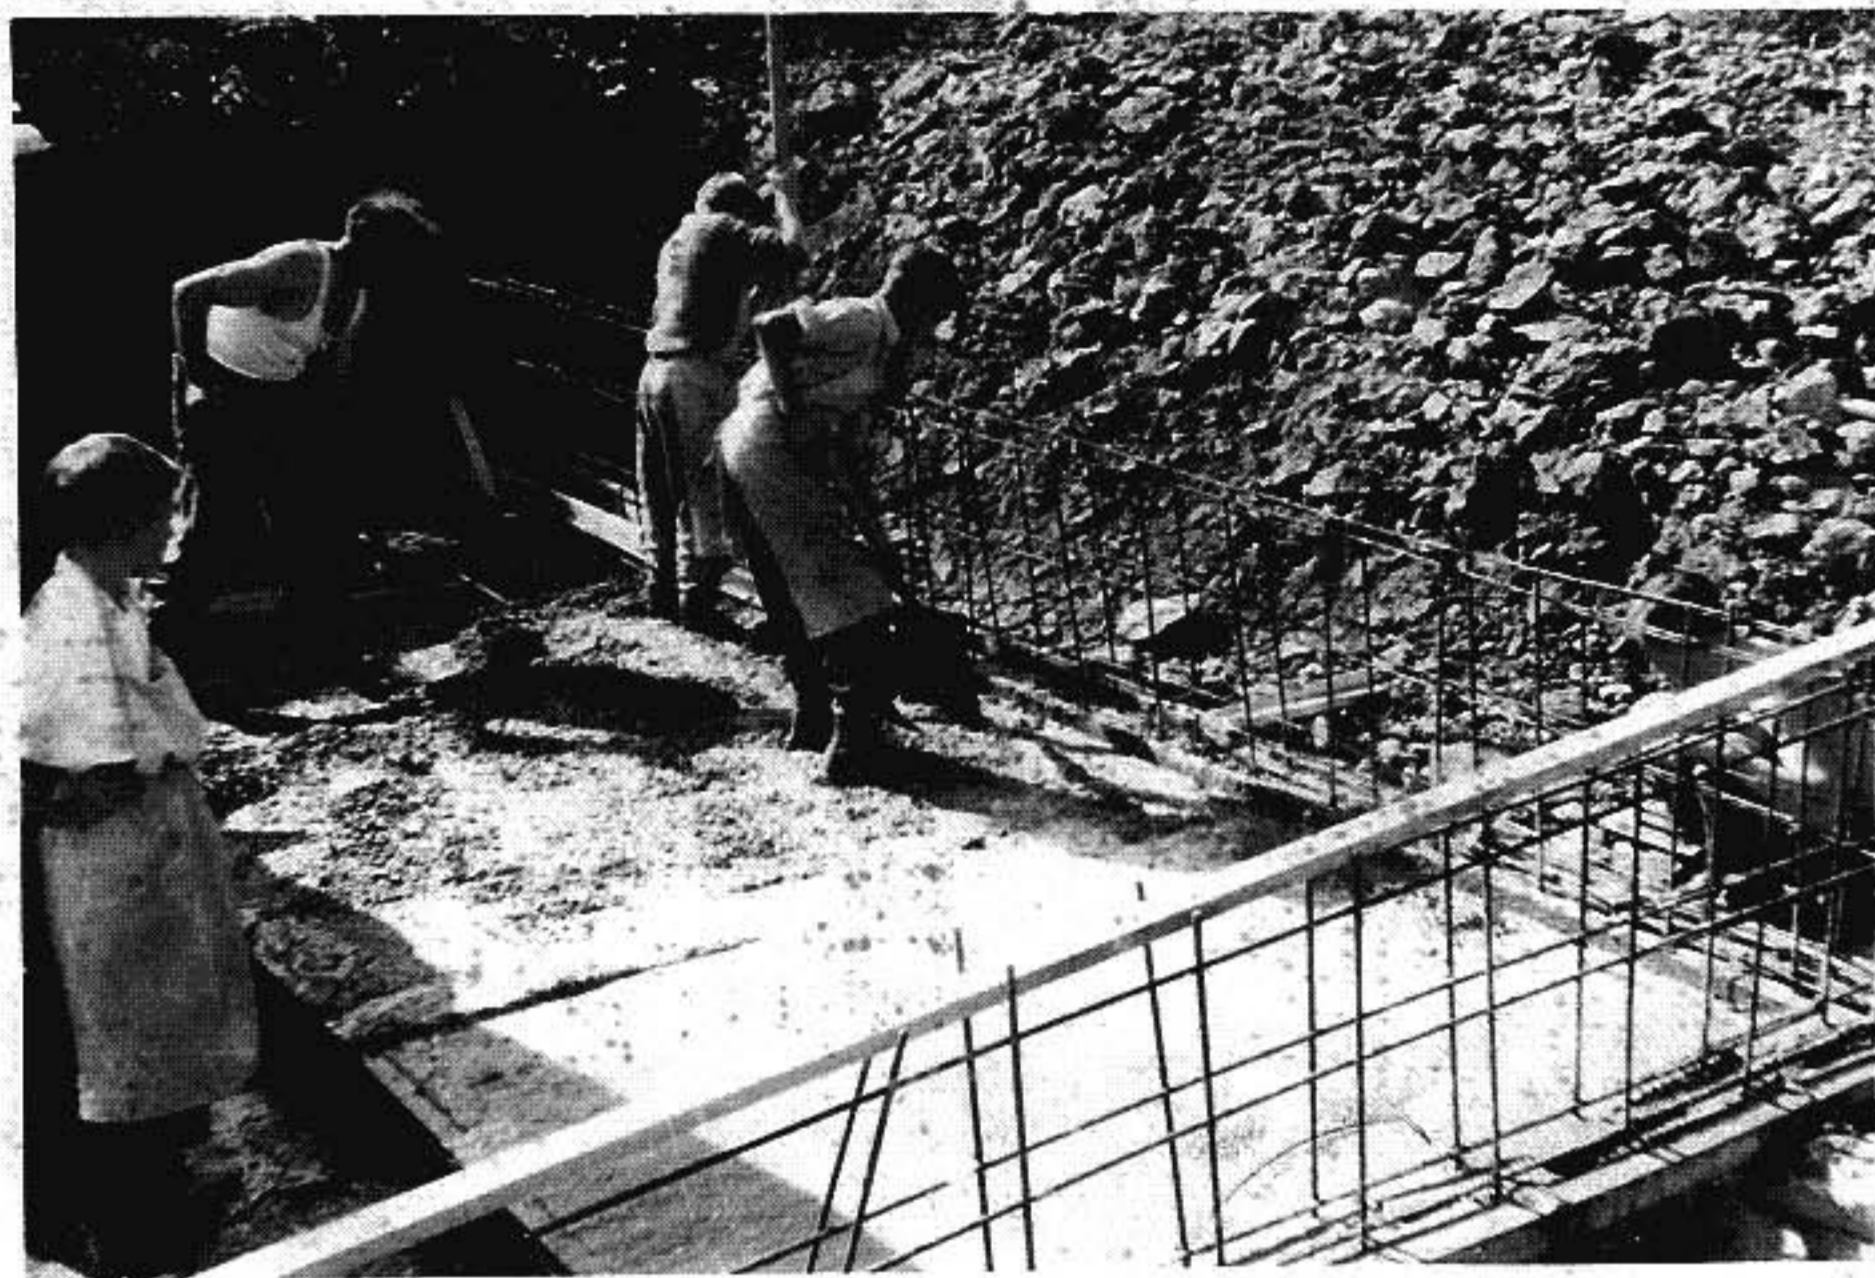
MAKING THE FIRST CAST.

One Monday morning, at the end of September, the first cast of the base was commenced. At 9.15, a cement grout was spread over the blinding enclosed by the shutter, and the boys were detailed to different jobs, to ensure that we should not be held up for the lack of either limestone, sand, cement or water.

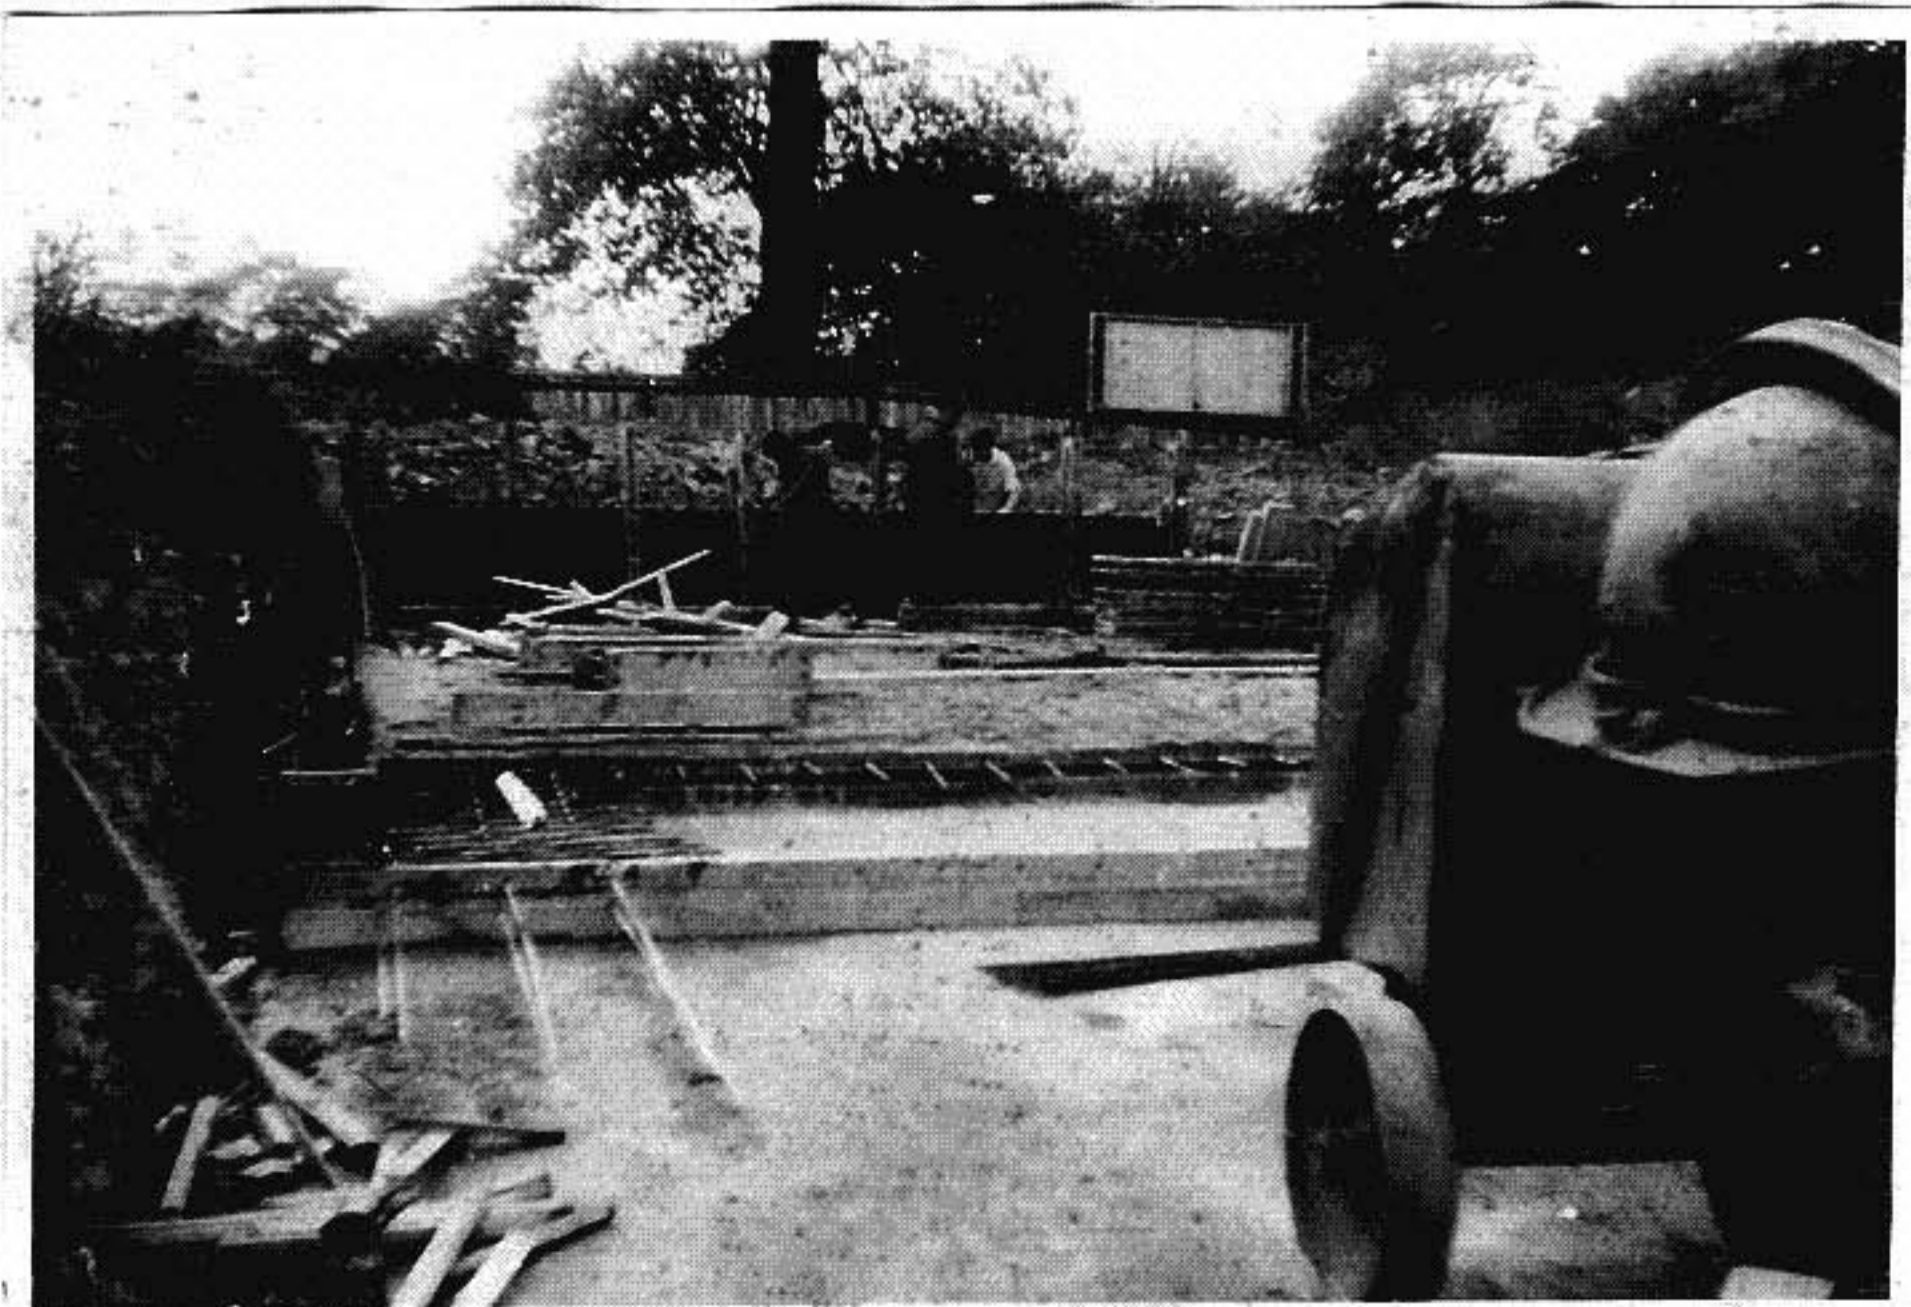
TRYING THE WALL SHUTTERS.

being trowelled, heavy steel pegs were inserted upright in the base to a depth of four inches. This resulted in a row of pegs in a line down the centre of the pool base, 10 feet from the position of the side walls to be used to anchor the bracing for the wall shuttering. This procedure was also carried out at each end of the pool for the same purpose. As soon as each cast had hardened, a thick layer of sand was spread over the surface and damped down. This layer was kept continually damp so that the drying period of the concrete was prolonged. This prevented cracking and powdering, possible if the surface had been exposed to the sun, which at times had been very hot, even so late in the year.

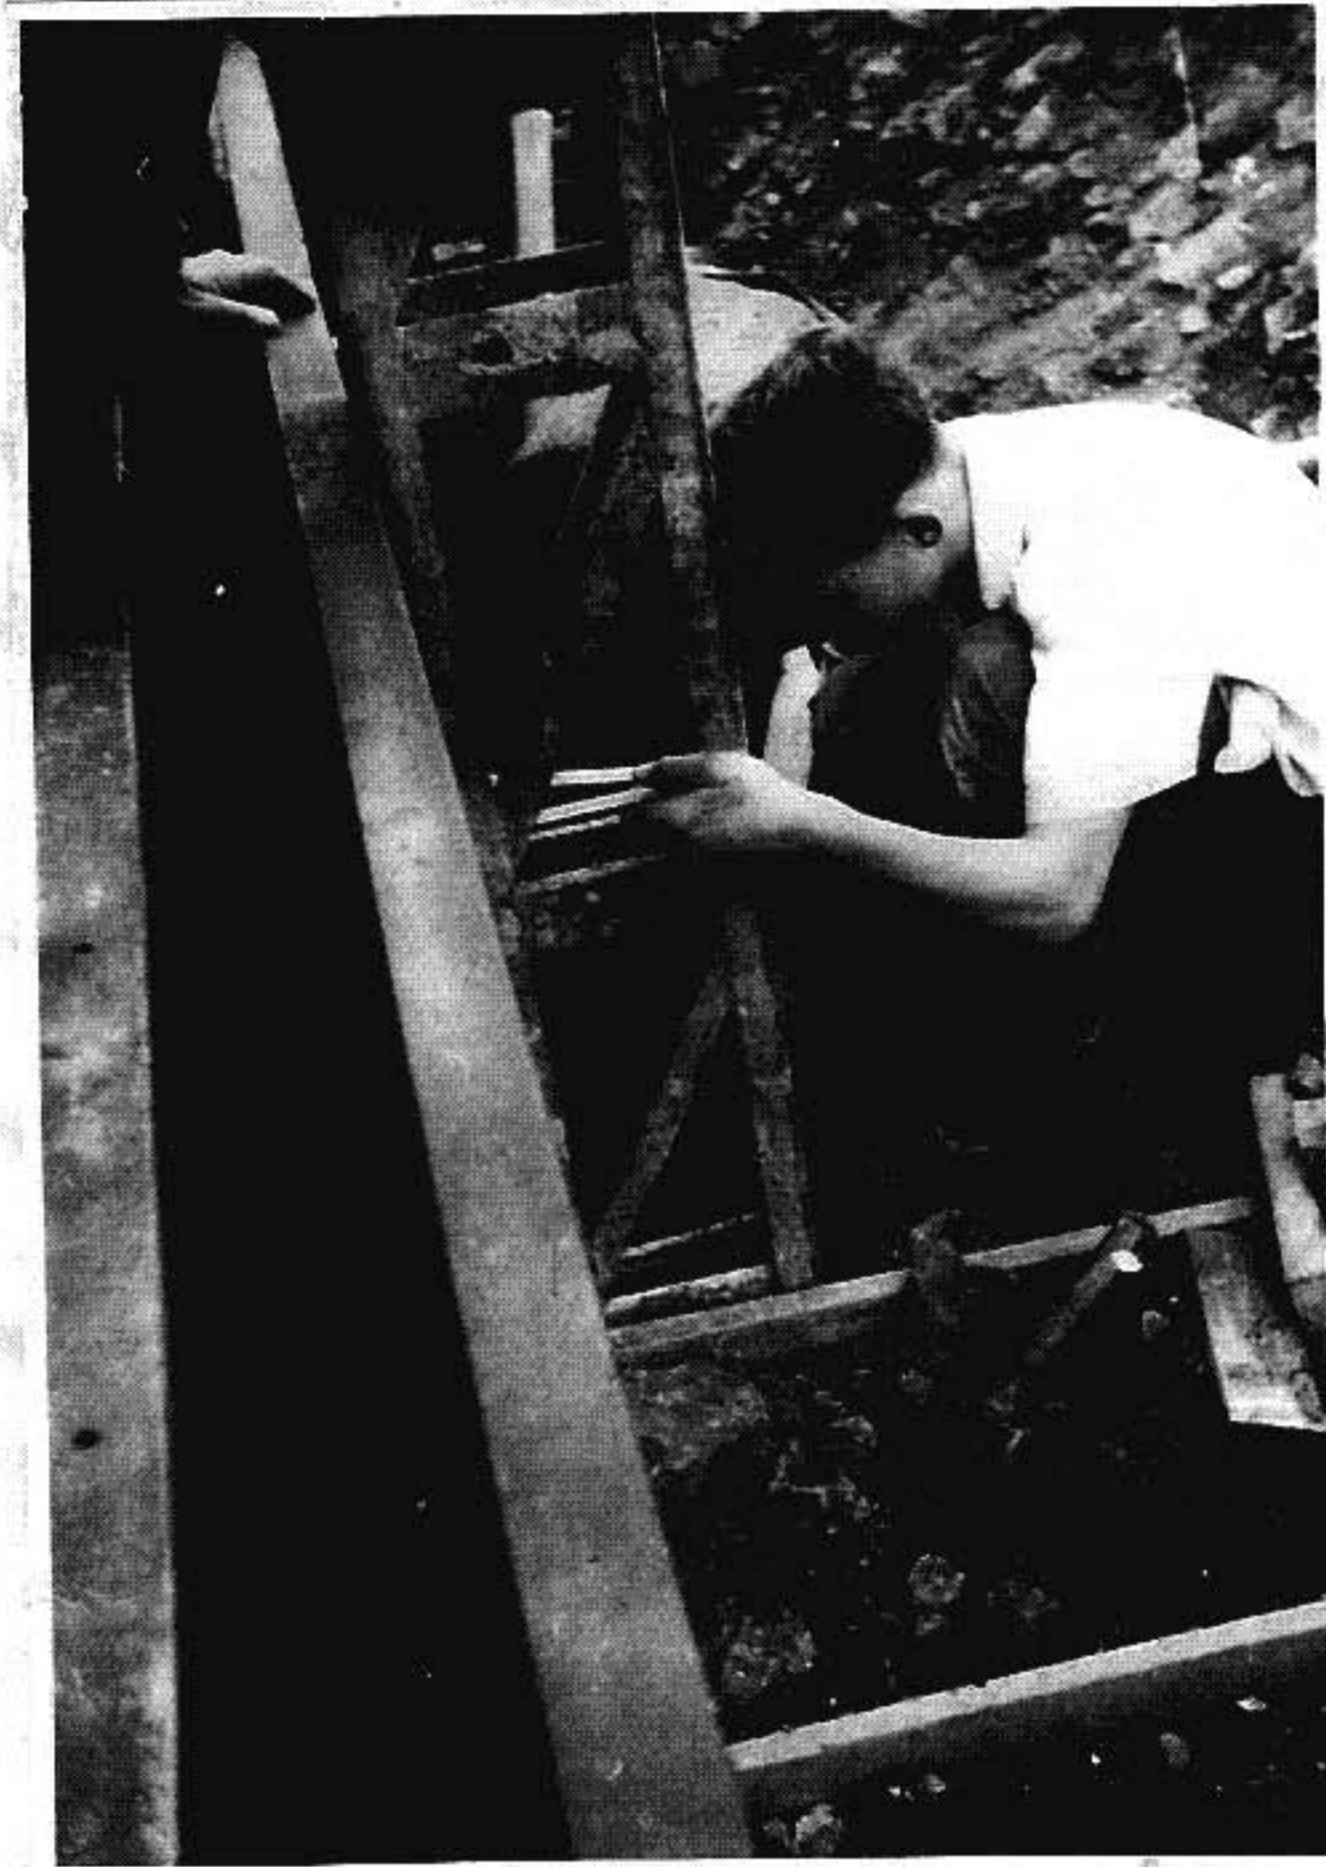
CLIPPING THE SHUTTERS.

By this time delivery had been made of sufficient steel shuttering to enable us to cast approximately 120 square feet of walling at one time. The walls were to be 9" in thickness, so that this amount of concrete could be easily handled in one day. The shuttering was complete with soldiers, clips and wedges, together with railway sleepers and a number of "Acrow" props for bracing. We obtained a large quantity of secondhand 4" x 2" timber for additional bracing and also laid in a large store of folding wedges. Once the boys had been shown the method of erection, we found the shuttering fairly easy to handle, although if not started off correctly, its weight made it rather difficult to manhandle. The shutters were placed in position and clipped back securely to the soldiers by means of spring clips and wedges, so presenting a smooth surface towards the face of the wall. Difficulty was found in forming the corners, as here it was necessary to introduce wooden formers, great care being required to ensure that these formers stood level with the face of the shutter.

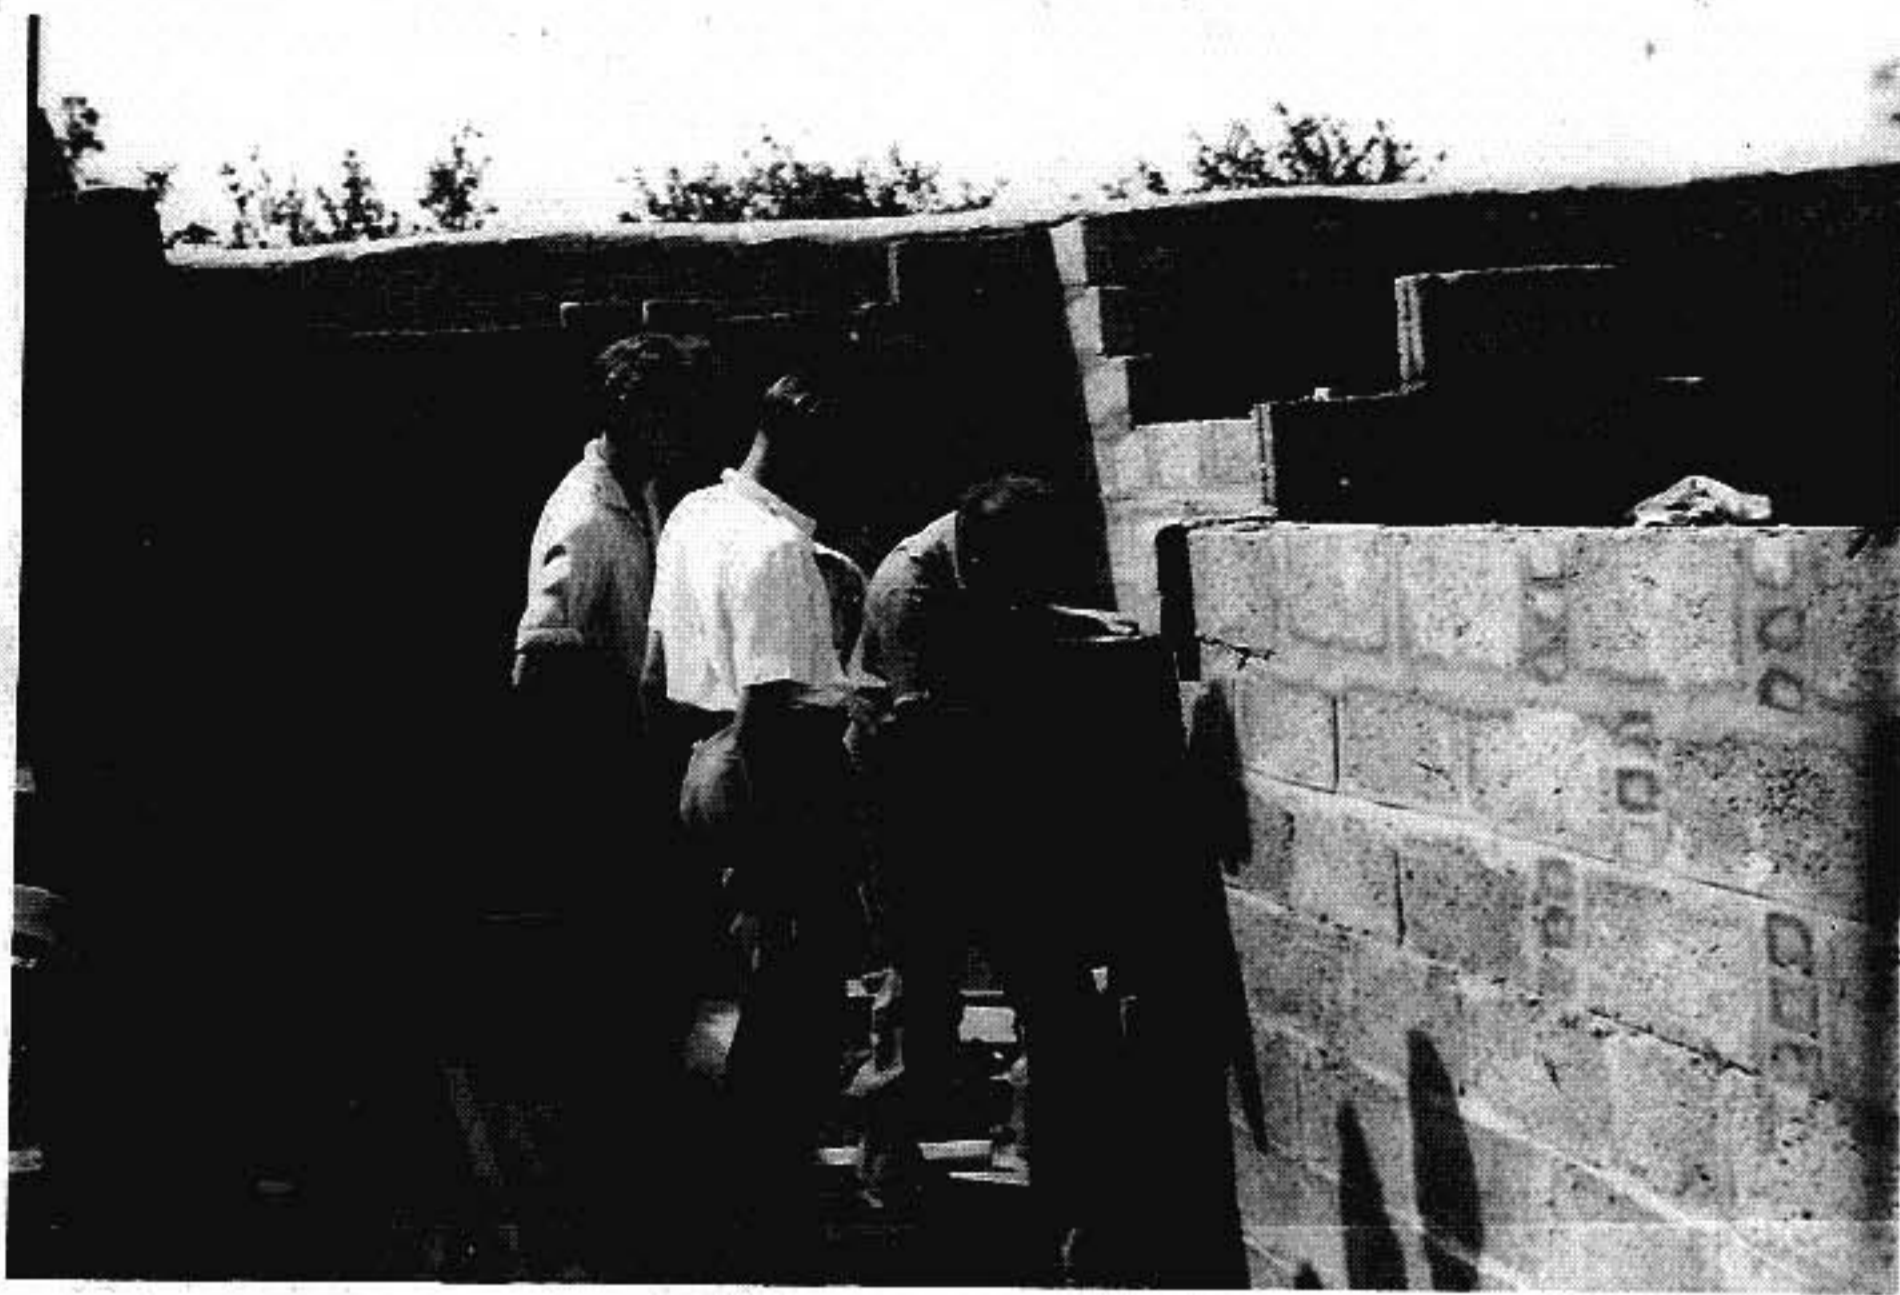
WORK ON THE PUMP HOUSE.

The pumphouse was therefore to stand on ground which had been very much disturbed by trenching etc., so the base was laid as a concrete raft reinforced with steel left over from the pool construction. Large trenches 18" deep were formed in this base so that the pipework could be fitted to various points of the plant. The bearing blocks for the filter vessel and the pump and electric motor were keyed to the base with steel bars, and cast in position. Messrs. Bell Bros were notified that the foundations were ready to receive the plant and work was continued erecting three of the pump house walls in 10" cavity blockwork. It was necessary to leave one wall of the pumphouse so that the filter vessel and other parts of the plant could be brought into position when needed.

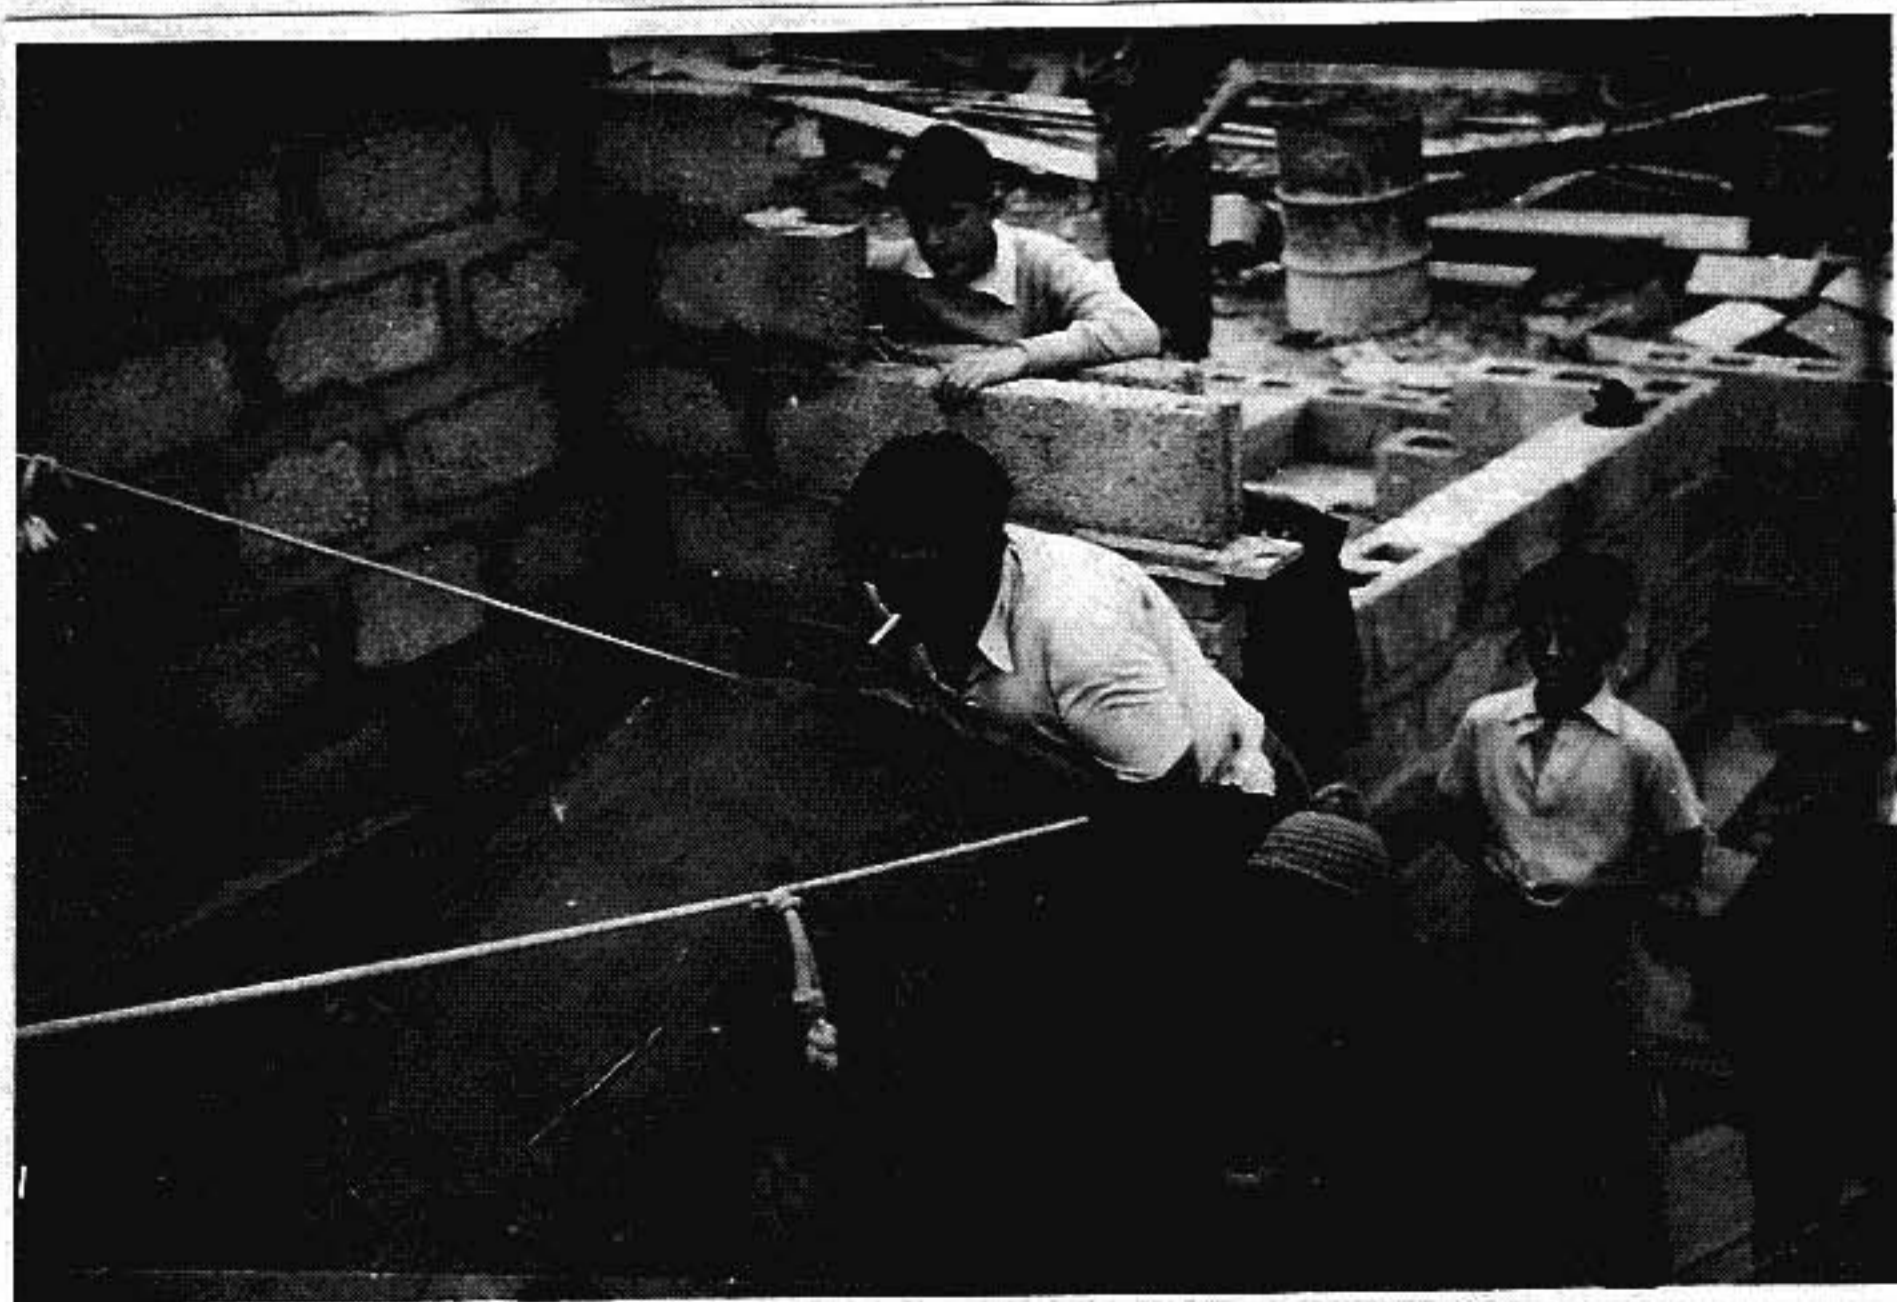
FIFTEEN CWTs. OF FILTER VESSEL.

When the plant was delivered we found that the filtration vessel was a terrific problem. Standing 5ft high, with a diameter of 4'6", it weighed 15 cwts and could only be moved with levers. Luckily the pumphouse had been sited very close to the entrance to the site, so that we only had a short distance to cover. A ramp was constructed to ease the vessel into position, this taking over a day to accomplish. Once again we were indebted to Mr Coward who provided most of the power required to move the tank. Having terrific strength, Mr Coward was called upon unceasingly throughout the scheme to move the apparently impossible. Boys would stand back and watch with amazement his displays of strength, to be reminded in no uncertain manner that they too were supposed to be helping.
