THE COUNTY SECONDARY SCHOOL

WOTTON-UNDER-EDGE, GLOUCESTERSHIRE.

CONSTRUCTION OF A SWIMMING POOL.

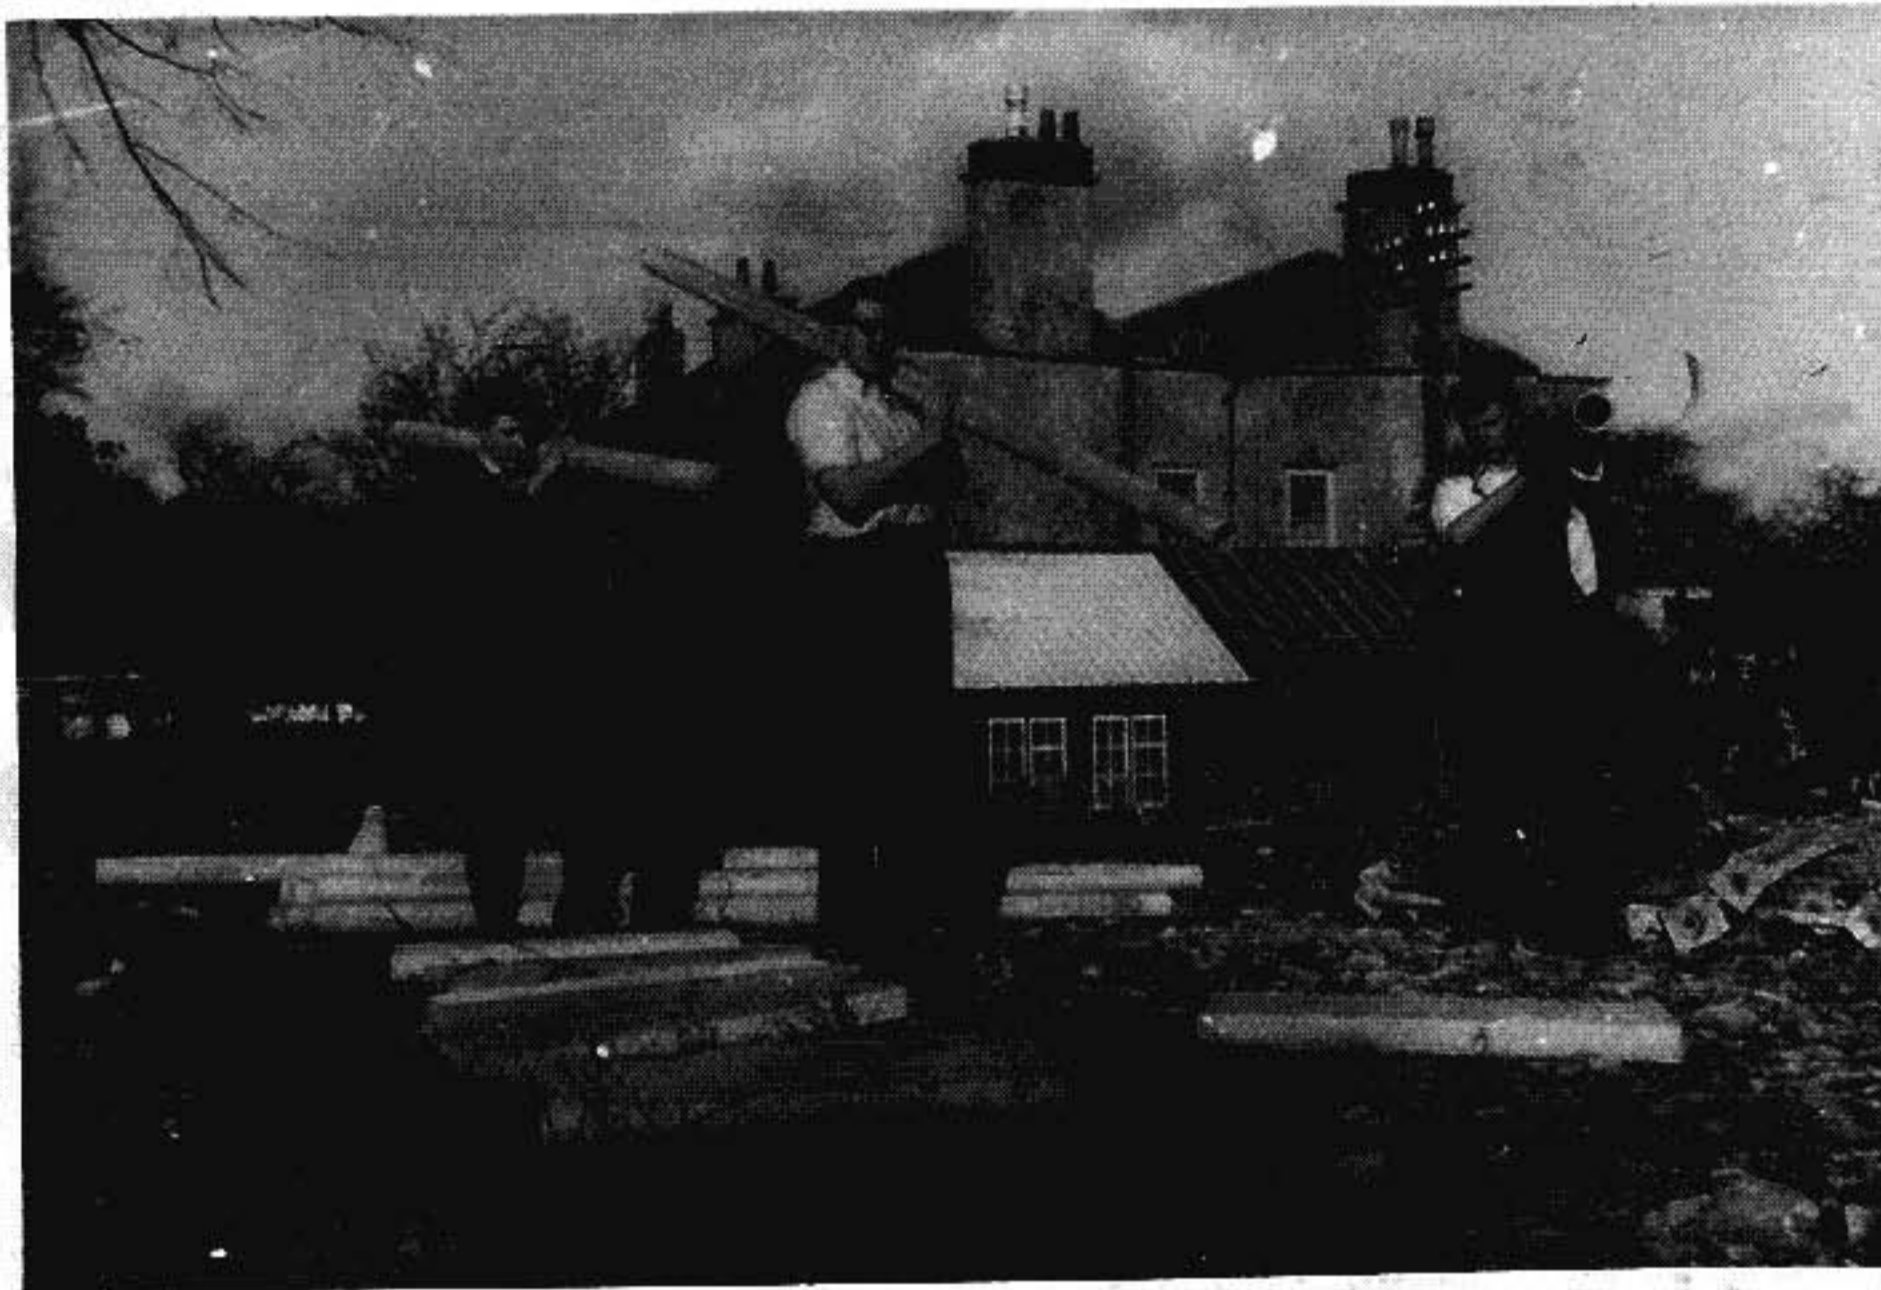
HIGH PRESSURE ASBESTOS PIPING.

We received a visit from the local representative of Messrs. Bell Bros. (Manchester) Ltd., and were able to discuss our exact position with him. Acting upon his advice, we decided to install high pressure asbestos pipework throughout, to avoid rust deposits in the water. This piping was also reputed to be easy to joint, using unskilled labour. It was possible for this firm to supply various types of plant, and as we wished to keep our costs to a minimum, we agreed upon the installation of a standard filter, capable of dealing with all pool water in $5\frac{1}{2}$ hours. The pump would be driven by a 3 phase electric motor and chemicals would be introduced into the water circulating through the plant by gravity drip feed. At a later date, if we so required, this method could be changed to injection of chlorine gas, a much more satisfactory way of chlorination, but more expensive to install.

of the pool, this pipework could be laid without much trenching, and being supplied in 10 ft lengths, was soon finished. The joints were simply made by rubber rings which were compressed on to a sleeve fitted over the pipes and then held in position by rebated brackets, locked with three bolts. Where a small length of piping was required, the odd length could be cut off with a hacksaw, the end trimmed with a rasp and normal jointing procedure carried out. When installed, all pipework on the site was water tested and all joints checked. After we were satisfied that the system was water tight, we bedded the pipes in concrete at intervals of 3'6" to prevent movement. At the same time all bends were completely surrounded by concrete as further security precautions.

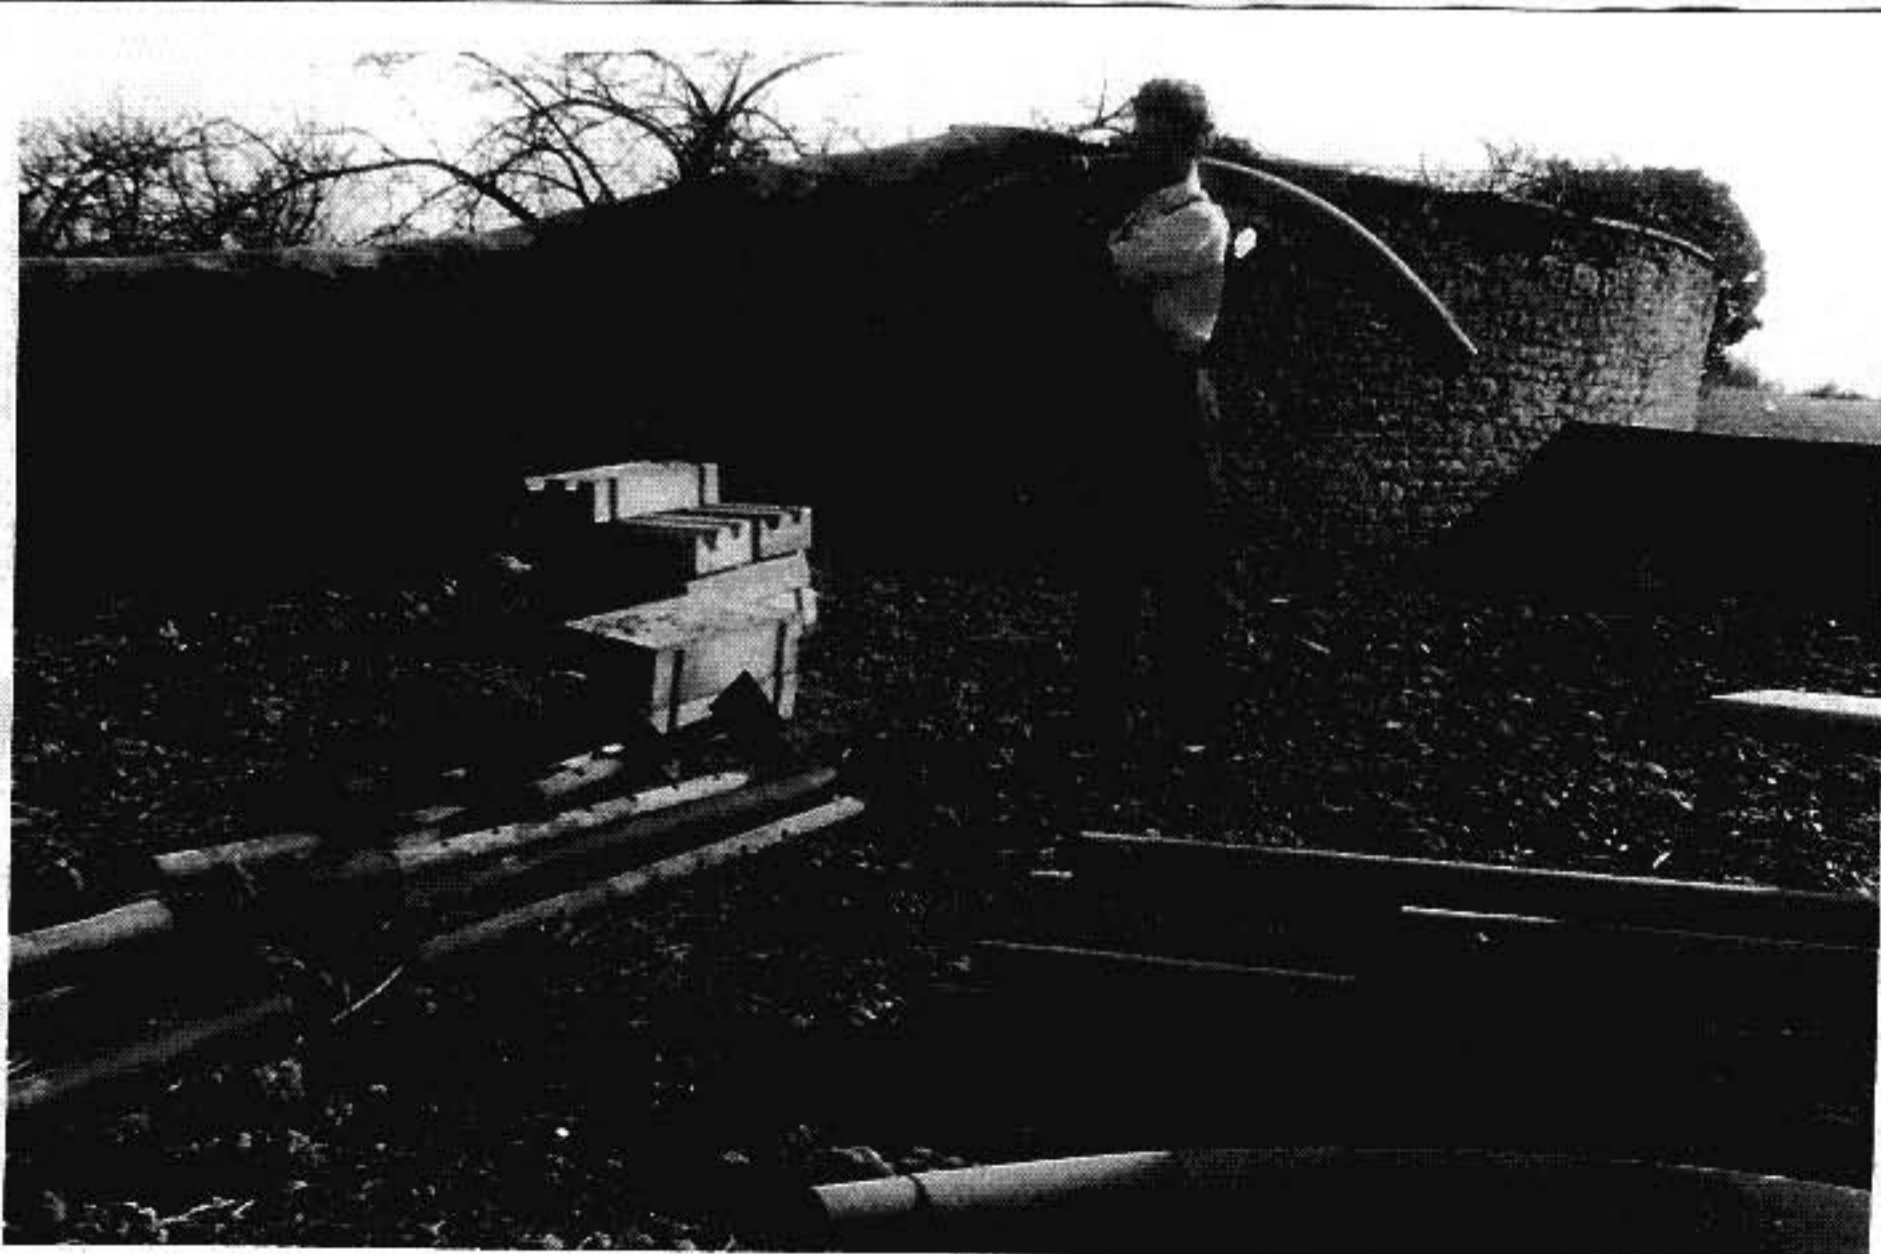
A 4" ASBESTOS PIPING BEND.

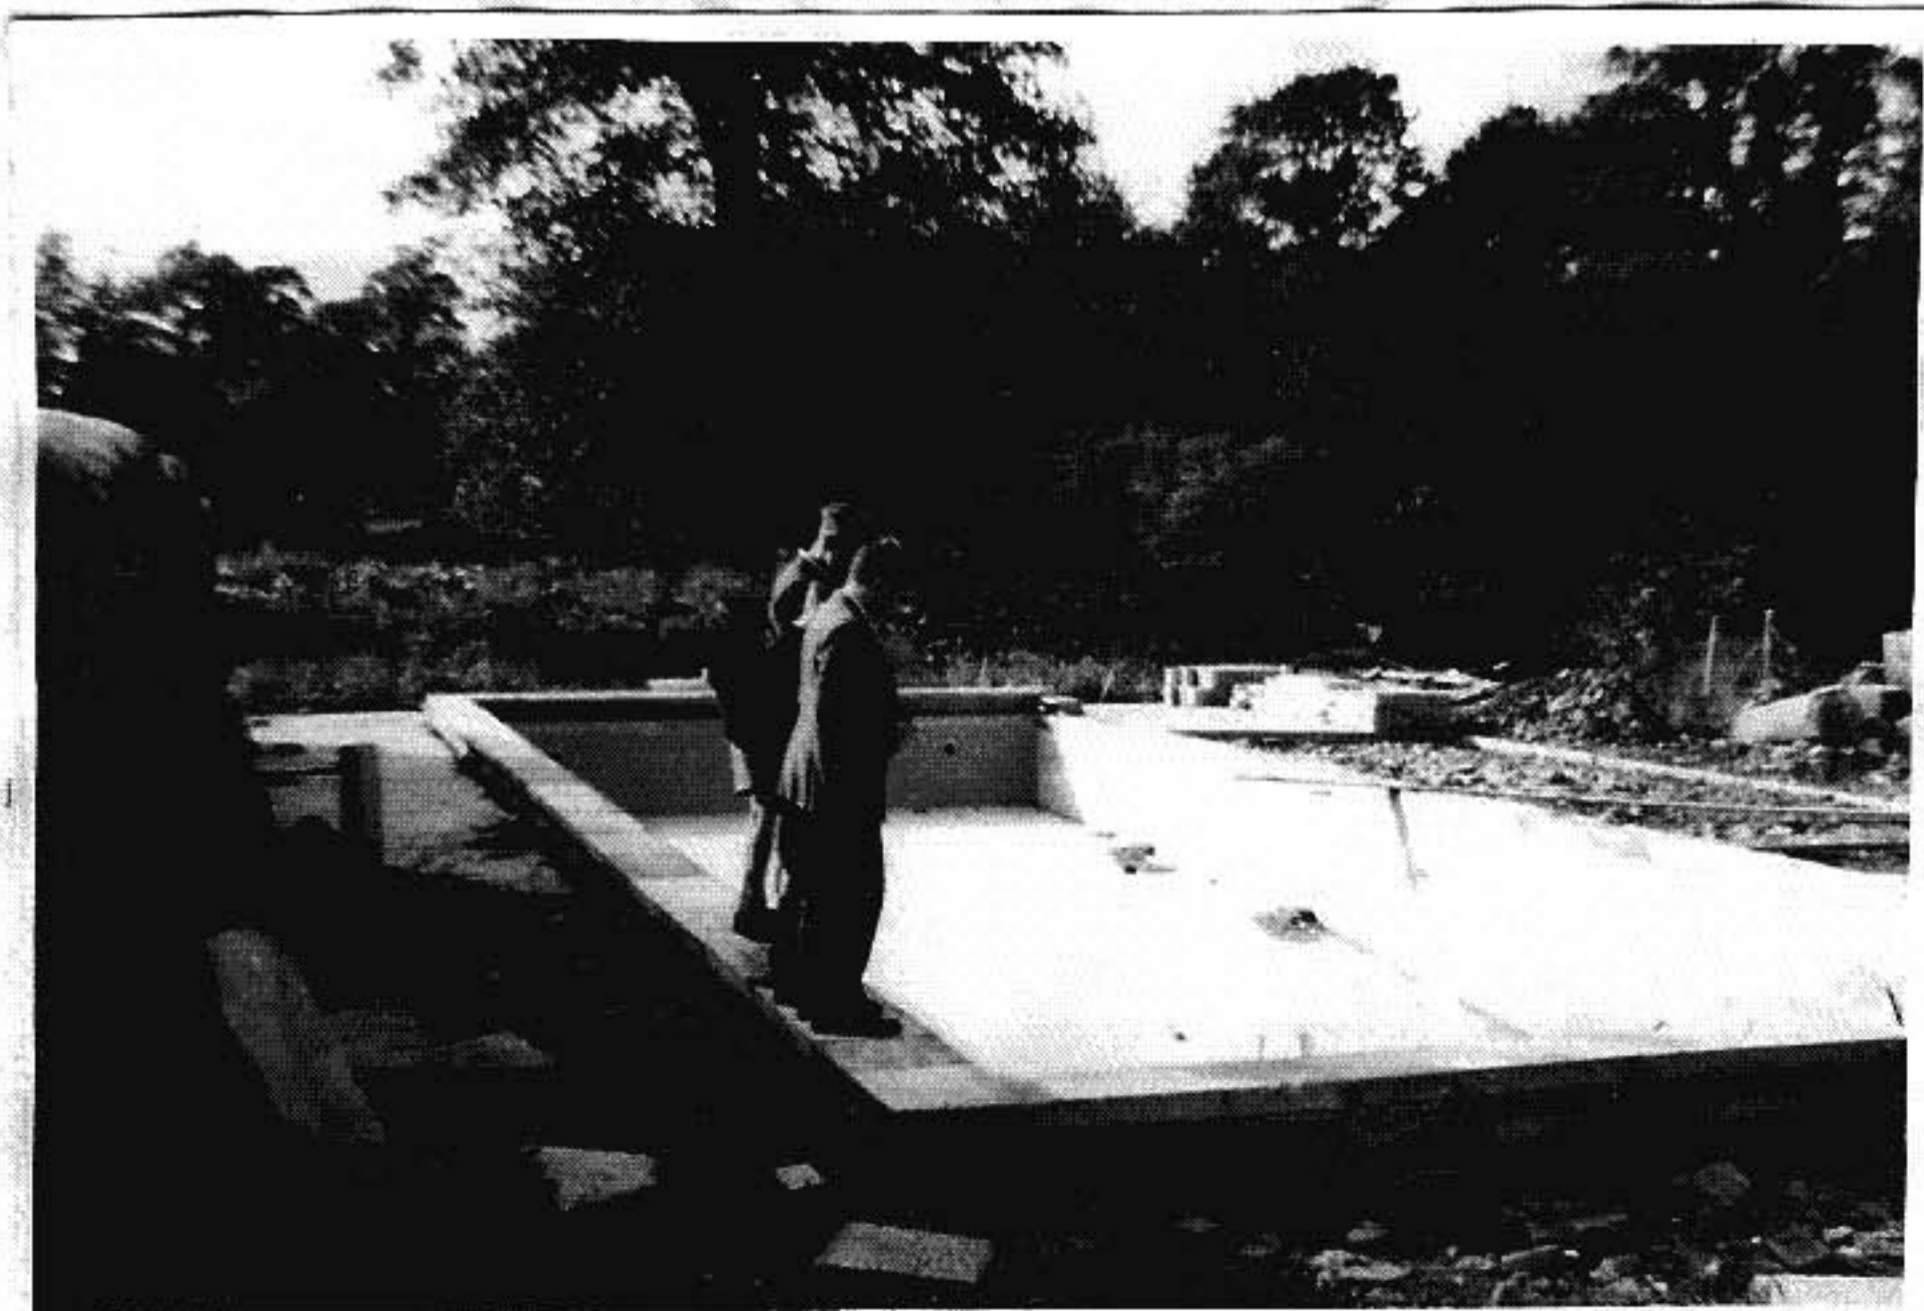
EDGING AND PAVING PARTIALLY COMPLETED.

Two footbaths were formed, one on either side of the fountain, drainage from them being taken to soak-a-ways away from the immediate vicinity. This part of the site was then completed by retaining walls, these being set out to ensure that all bathers would be directed through the footbaths before entering the bathing area.

We were then able to cast the paving surround of the pool. This was designed so that the swimming instructors would be able to stand at water level around a great deal of the pool, but also at the deep end, where plunging would be possible, the levels were brought up flush with the top edge of the coping stones. The whole of this paving, 4" thick, took over 20 cu. yards of concrete for its completion.
